Dr David Ford says concrete ponds are prone to leakages, especially after winter frosts

The Slow Leaking Pond

A step by step guide to easily solve the problem

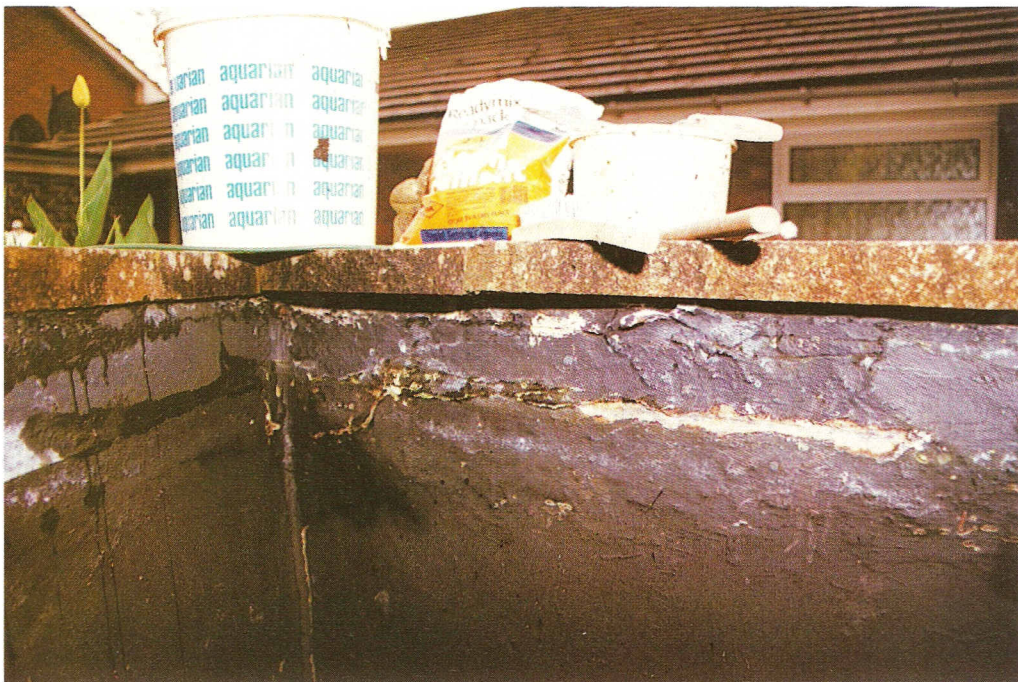
RIGHT
Close-up of the area showing a crack in the polypaint seal being chopped open.

Using a hammer and chisel chop into the damaged area and dig out all the soft concrete, cutting back into a good, solid concrete.

Chop away any polypaint beyond this area too and then scrub well with a wire brush.
